**THE SECRETARY OF THE INTERIOR'S STANDARDS FOR THE TREATMENT OF
HISTORIC PROPERTIES**

The Secretary of the Interior's Standards
for the Treatment of Historic Properties

with Guidelines for
Preserving, Rehabilitating
Restoring & Reconstructing
Historic Buildings

Kay D. Weeks and Anne E. Grimmer

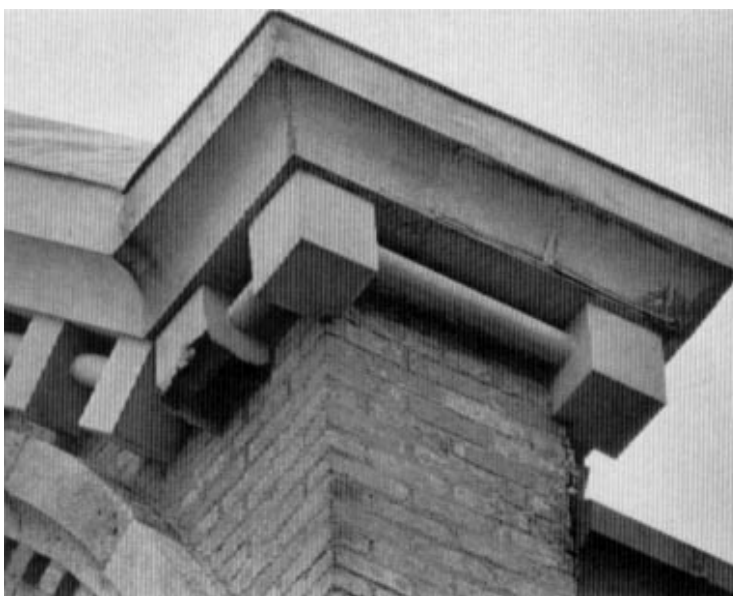
Two examples of “limited replacement in kind” point out an appropriate scope of work within the treatment, Preservation. (a) One metal modillion that has sustained damage from a faulty gutter will need to be replaced; and (b) targeted repairs to deteriorated wood cornice elements (fascia board and modillions) meant that most of the historic materials were retained in the work.

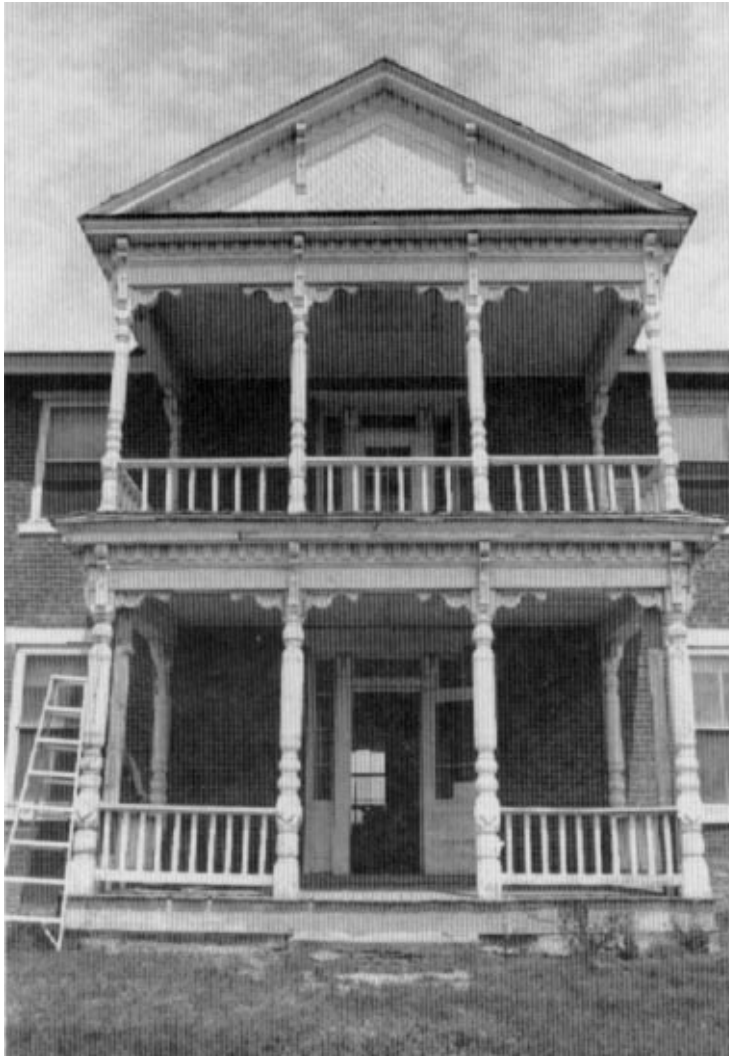
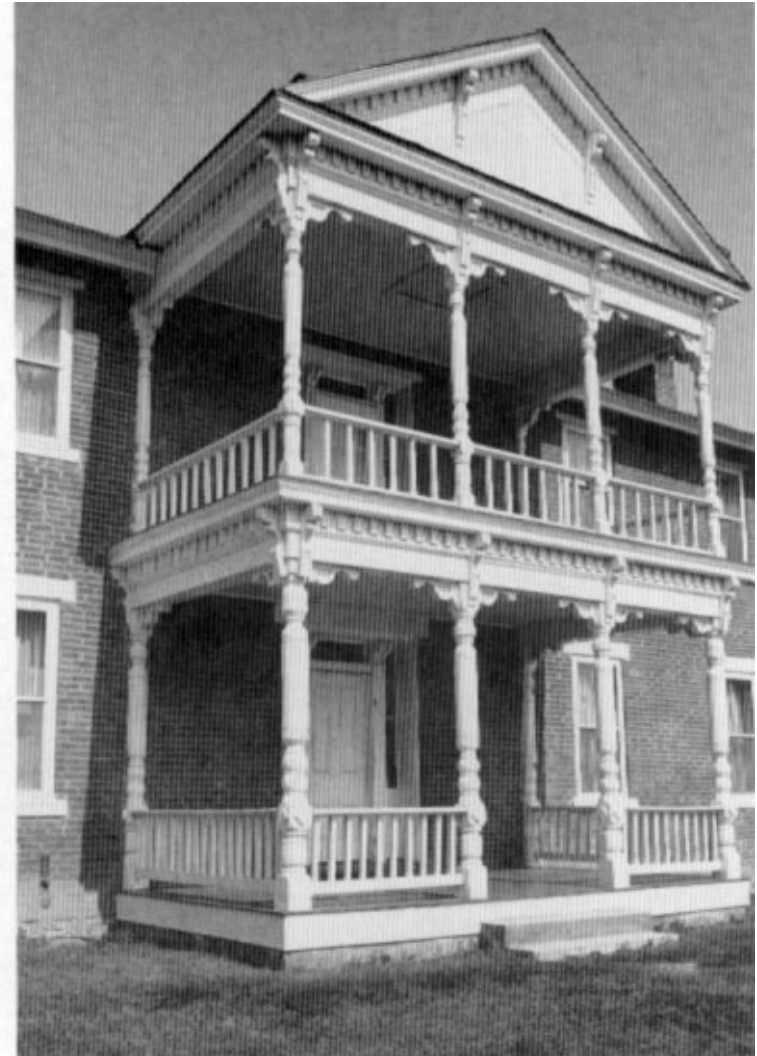
In Rehabilitation, deteriorated features should be repaired, whenever possible, and replaced when the severity of the damage makes it necessary. Here, a two-story porch is seen prior to treatment (left). The floor boards are rotted out and the columns are in a state of collapse, supported only by crude, temporary shafts. Other components are in varying stages of decay. Appropriate work on the historic porch (right) included repairs to the porch rails; and total replacement of the extensively deteriorated columns and floor boards. Some dismantling of the porch was necessary.

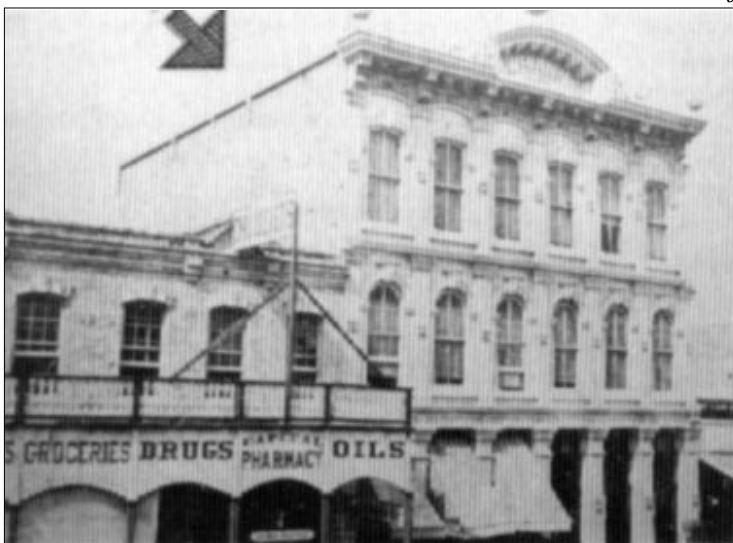
In the treatment, Rehabilitation, one option for replacing missing historic features is to use pictorial documentation and/or physical evidence to re-create the historic feature. (a) In this example, the ornamental cornice of an 1866 limestone building was missing; and the ground level storefront had been extensively altered. (b) and (c) Based on the availability of photographic and other documentation, the owners were able to accurately restore the cornice and storefront to their historic configuration. A substitute material, fiberglass, was used to fabricate the missing pressed metal cornice, an acceptable alternative in this project. All work met the Standards.

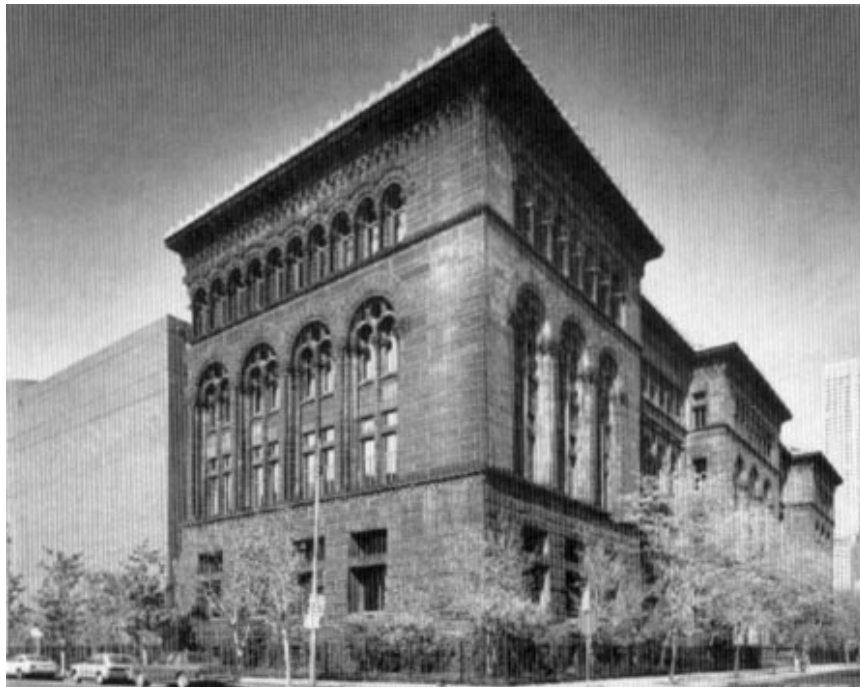
Rehabilitation, like Preservation, acknowledges a building's change over time; the retention and repair of existing historic materials and features is thus always recommended. However, unlike Preservation, the dual goal of Rehabilitation is to—respectfully—add to or alter a building in order to meet new use requirements. This downtown Chicago library was expanded in 1981 when additional space was required with light and humidity control for the rare book collection. The compatible 10-story wing was linked to the historic block on side and rear elevations. Its simple design is compatible with the historic form, features, and detailing; old and new are clearly differentiated. Photo: Dave Clifton.

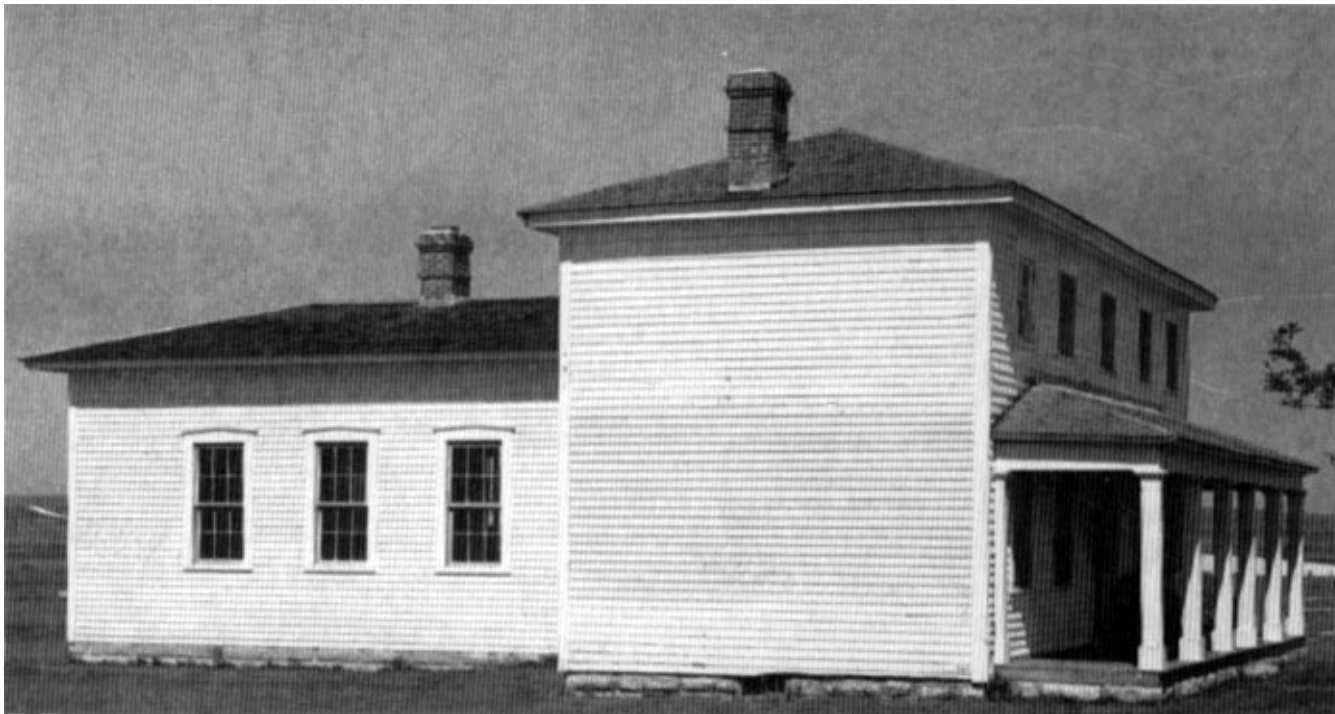
In a project at Fort Hays, Kansas, the wood frame officers' quarters were restored to the late 1860s—their period of significance. This included replacing a missing kitchen ell, chimneys, porch columns, and cornice, and closing a later window opening in the main block. The building and others in the museum complex is used to interpret frontier history.

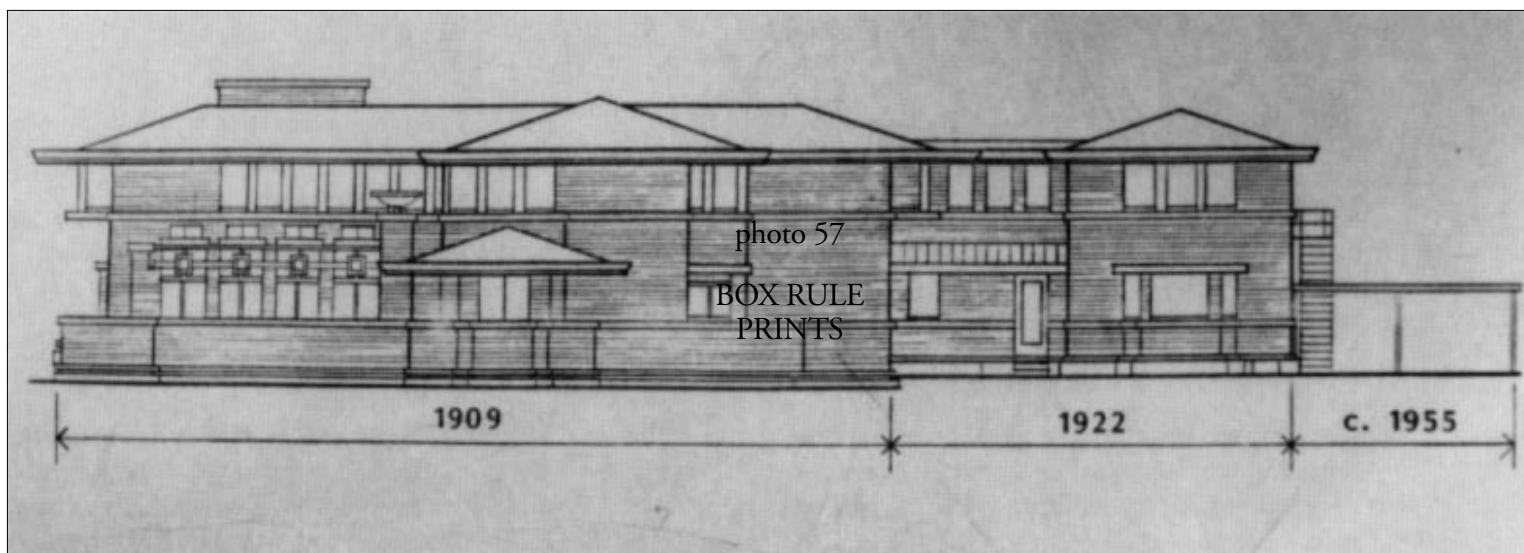
The Meyer May House in Grand Rapids, Michigan, was designed by Frank Lloyd Wright and built in 1909. In 1922, May added to the house for an expanding family. After the May occupancy, the house was altered for use as apartments, with a carport added in 1955. In the 1980s restoration, the Wright's original design was deemed more significant than May's later changes, and, as a result, the additions were removed and the house returned to its 1909 appearance. Drawing: Martha L. Werenfels, AIA.

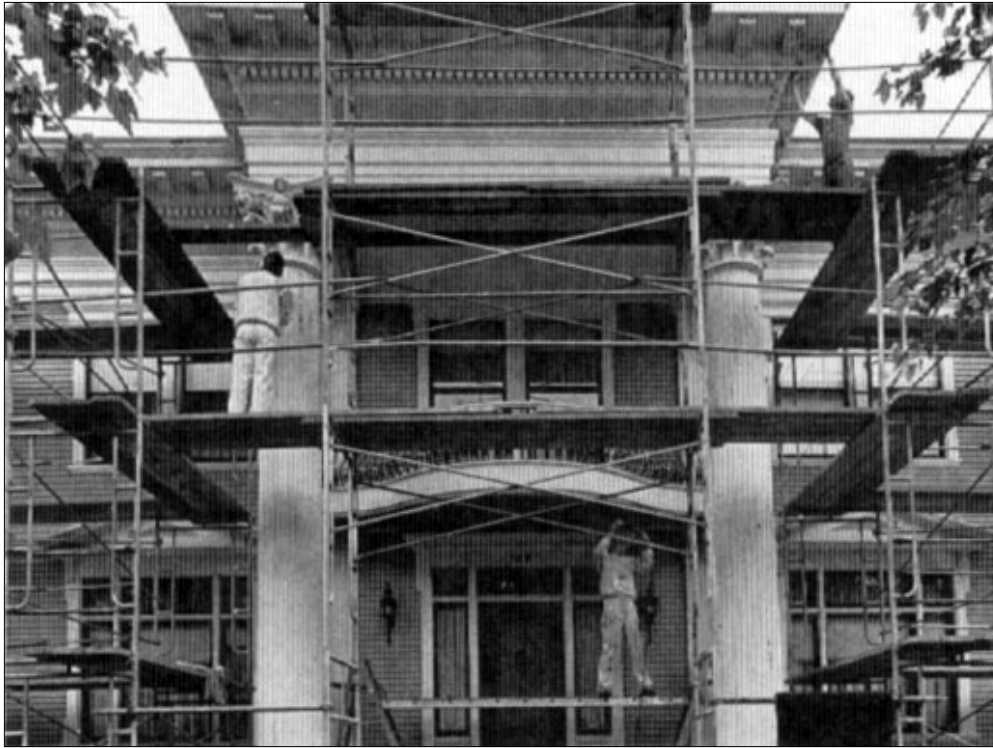
Ongoing work at this house focuses on the maintenance and repair of exterior wood features from the restoration period. After scraping and sanding, the wood was painted in colors documented to the Restoration period. Photo: ©Mary Randlett, 1992.

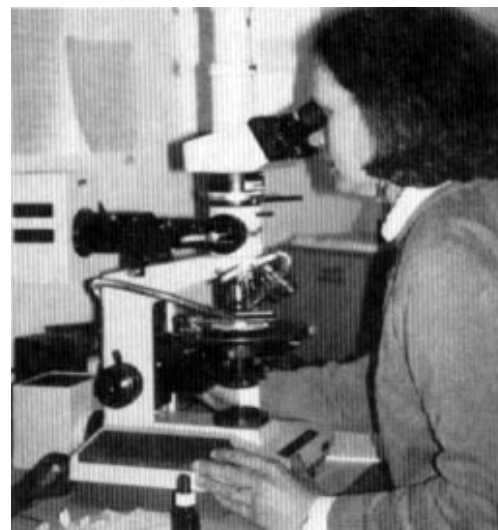
A complete paint investigation often needs to be conducted during Restoration. Paint samples are carefully collected onsite. In the laboratory, an ultra violet light is used to identify pigment and binding media. Paint samples are then photographed. Physical evidence documented through laboratory research provides a sound basis for an accurate restoration of painted finishes, such as the complex stencilling pictured here. Photo left: Courtesy, Alexis Elza; Photo right: Courtesy, Andrea Gilmore.

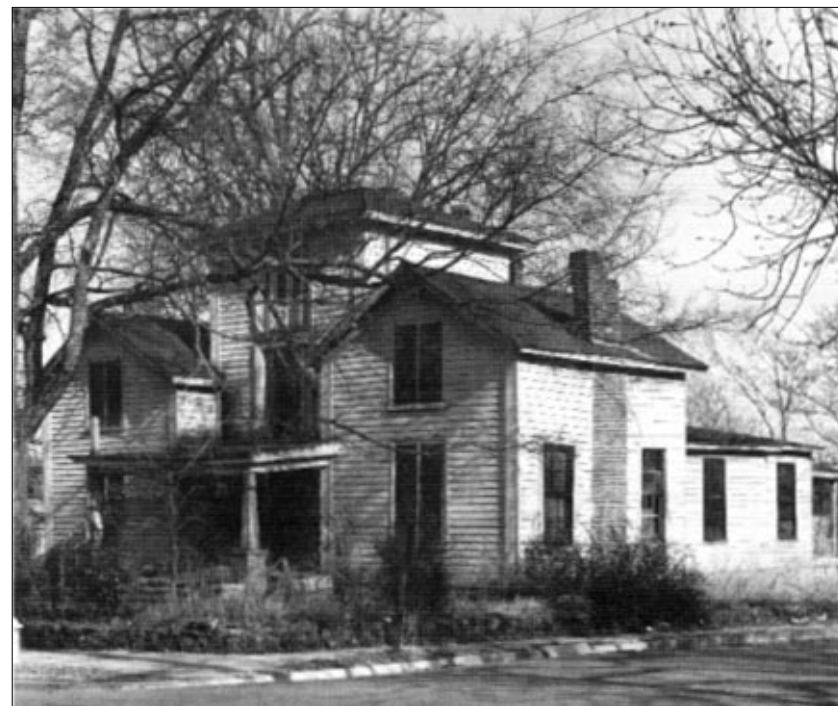
This ca. 1900 photograph (left) would be invaluable to guide restoration of the deteriorated house (right) to its documented earlier appearance, complete with decorative trim, shutters, polychromed exterior, and fencing. Photos: Courtesy, North Carolina Department of Archives and History.

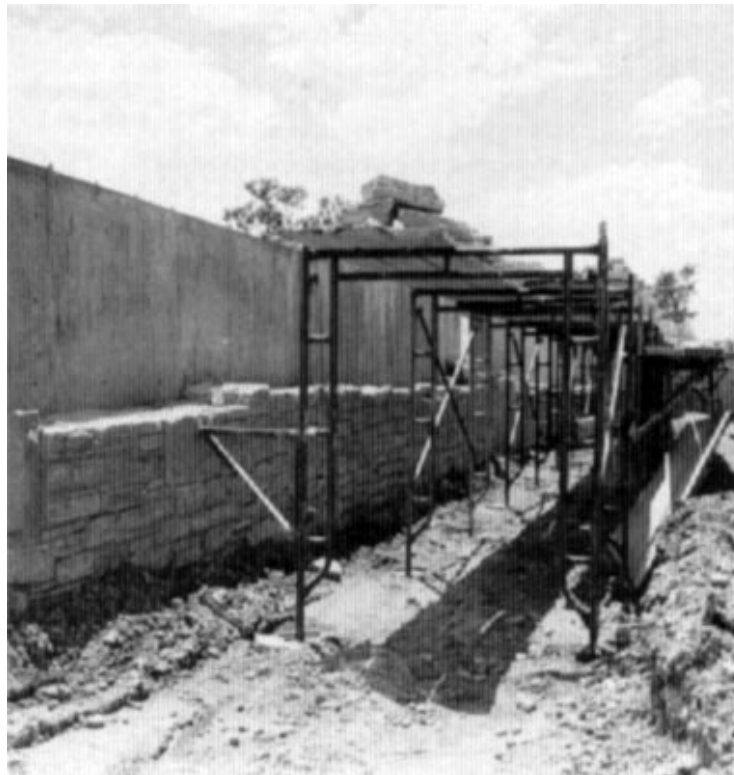
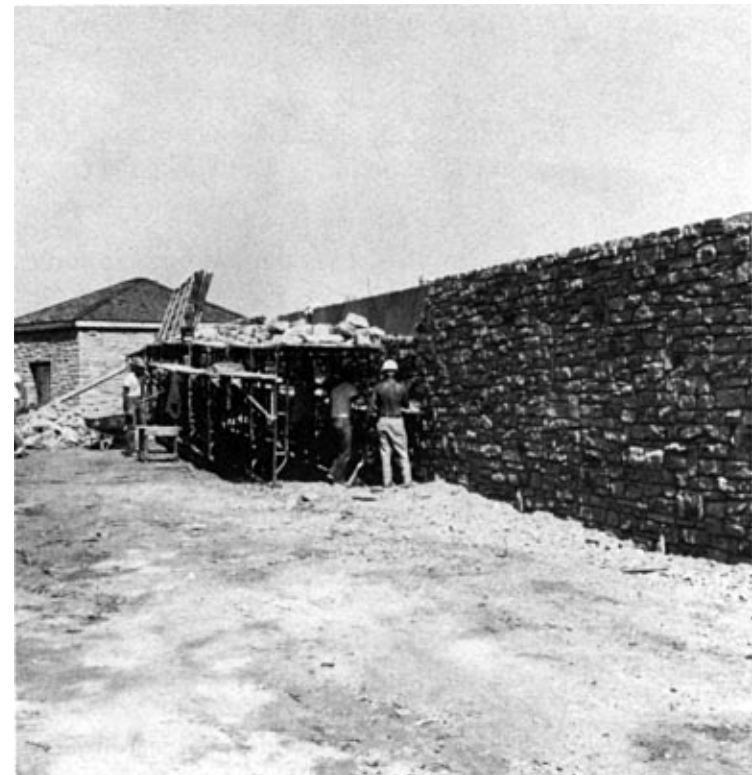
(a) and (b). Two photos illustrate the use of contemporary construction materials and techniques within the treatment, Reconstruction. Because Reconstruction is employed to portray a significant earlier time, usually for interpretive purposes, substitute materials may be appropriate if they are able to convey the historic appearance.

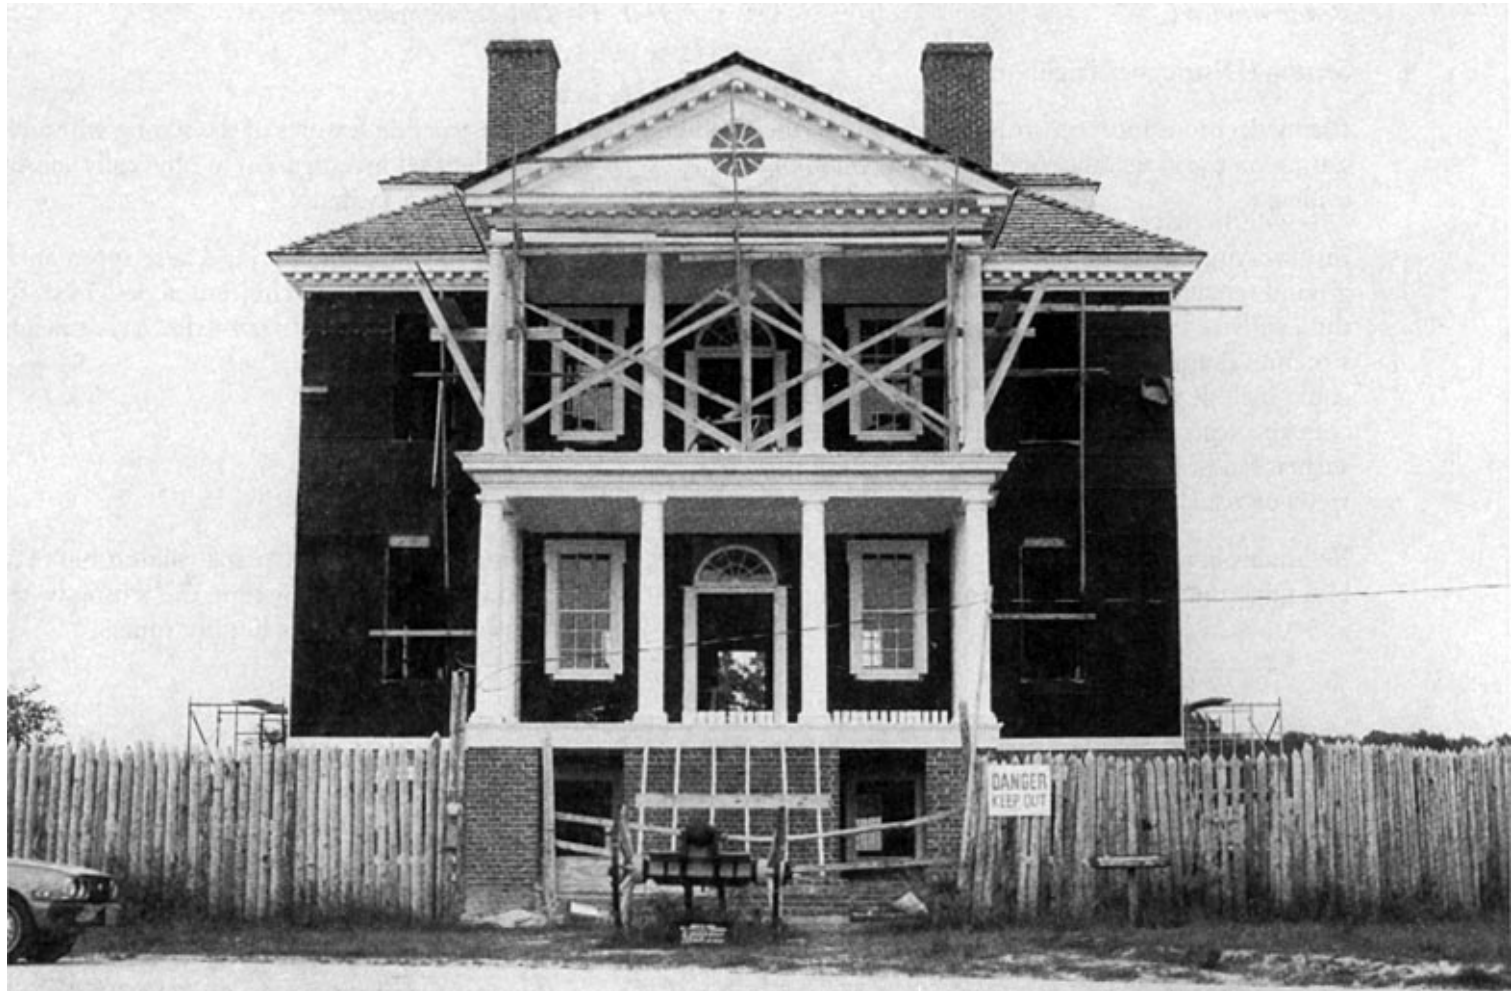
The 1778 Kershaw House, which served as British Headquarters during the Revolutionary War, was burned by Union troops in 1865. In the early 1970s, the house was reconstructed as part of Camden Battlefield, Camden, South Carolina. Built expressly for interpretive purposes, it serves as an illustrative reminder of a past event of national significance. The Standards for Reconstruction call for any re-created building to be clearly identified as a contemporary depiction. This is most often done by means of an exterior sign or plaque, or through an explanatory brochure or exhibit. A guide may inform visitors as well. Photo: Richard Frear.
